PROJECT: Lebanon Utilities Building
CITY, STATE: Lebanon, IN

FIELD REPORT NO. 010
ARCHITECT'S PROJECT NO. 13022

DATE: March 22, 2016 **TIME:** 2:30 pm
TEMPERATURE RANGE: 60° F
EST'D % OF COMPLETION: 98%

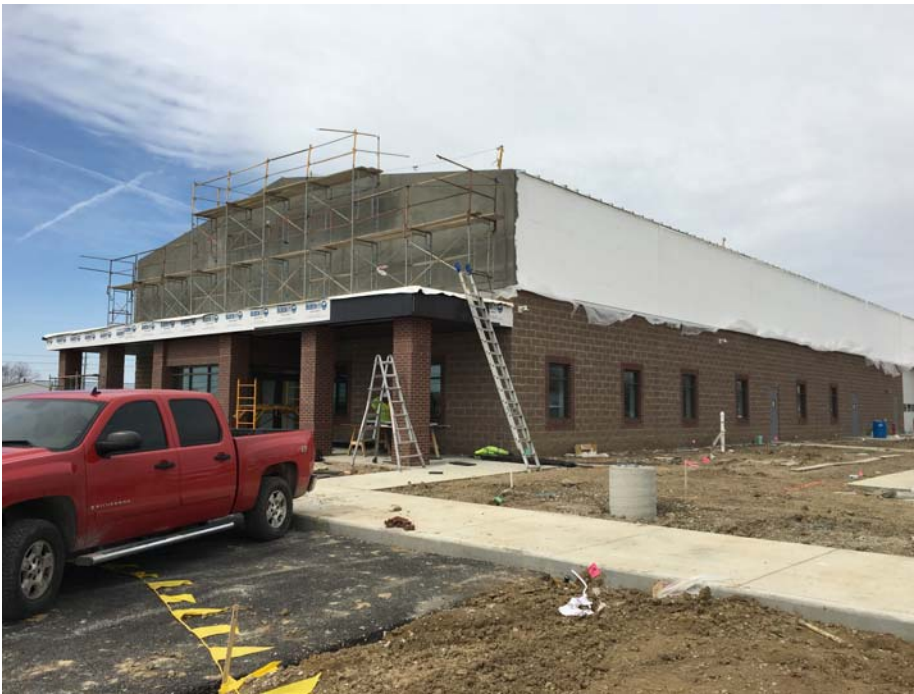
SE corner of building.

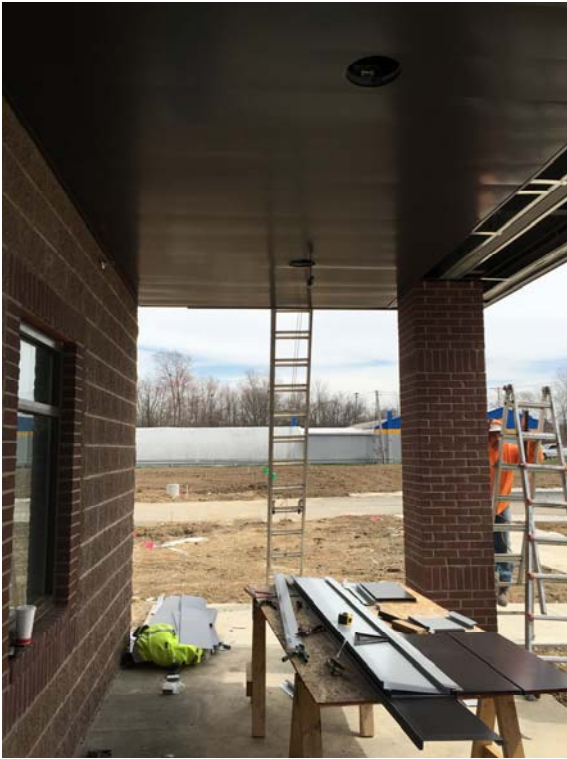
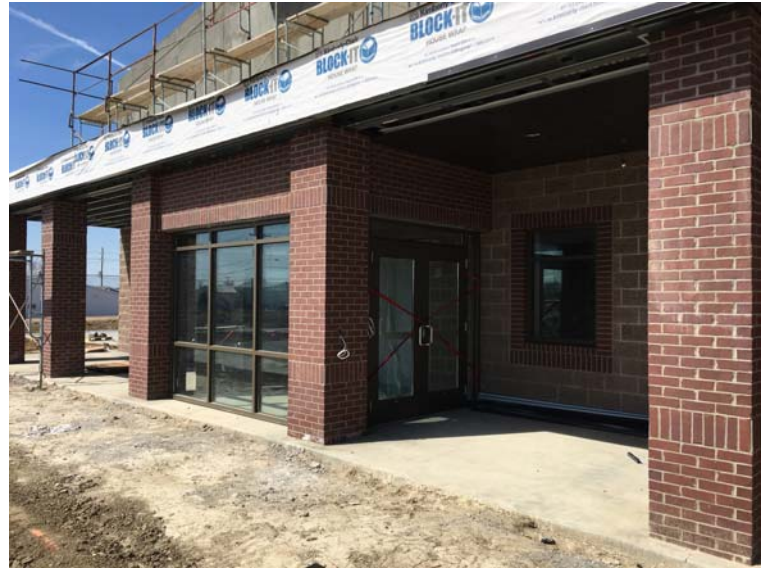
Brick columns and canopy with metal soffit panels. Storefront entry installed at vestibule and in lobby.

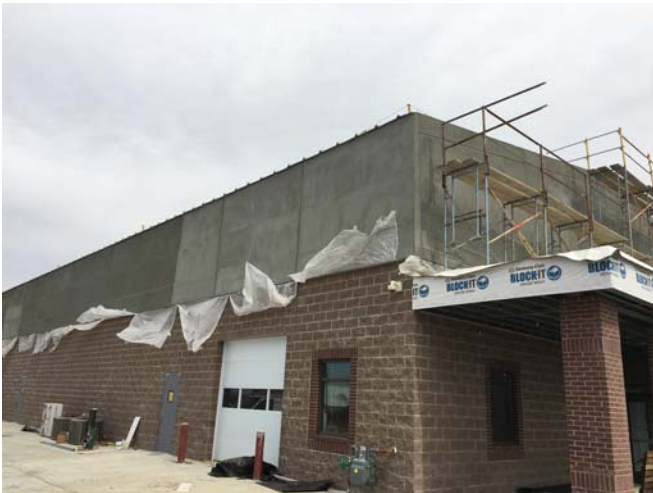
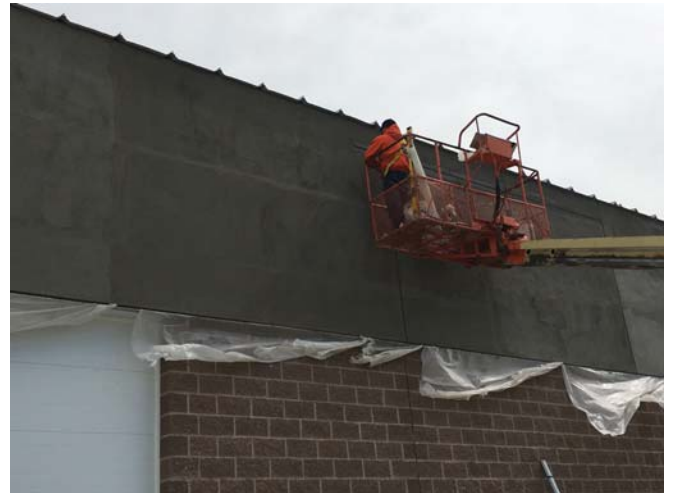
Installation of EIFS with control joints and reveal

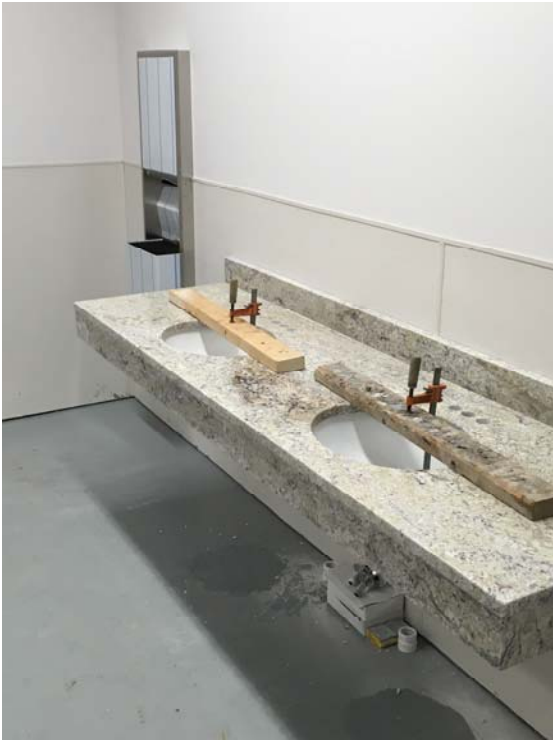
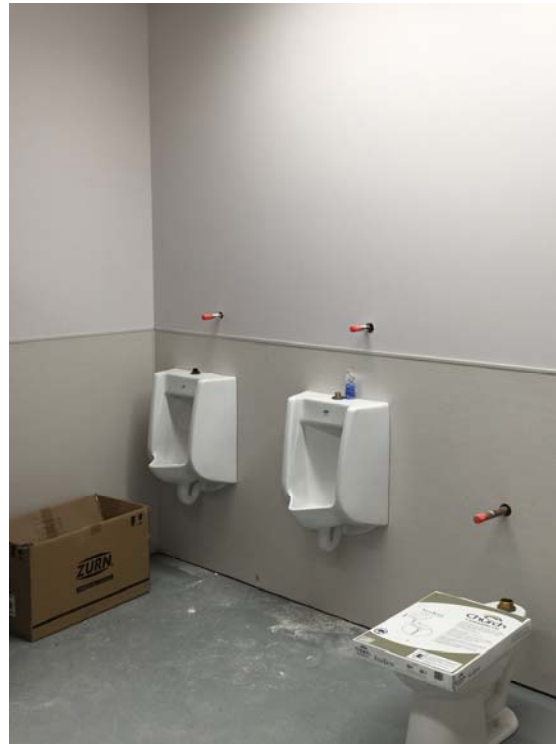
Granite countertop and backsplash installed. Paper towel dispenser & waster receptacle installed. Urinal installed, toilets have yet to be installed. Flush valves have not yet been installed. Restroom wall and floor finish installed. Grab bars have been installed.

- Paint interior door frames
- Install WC and toilet partitions
- Installation of solar panels on canopy

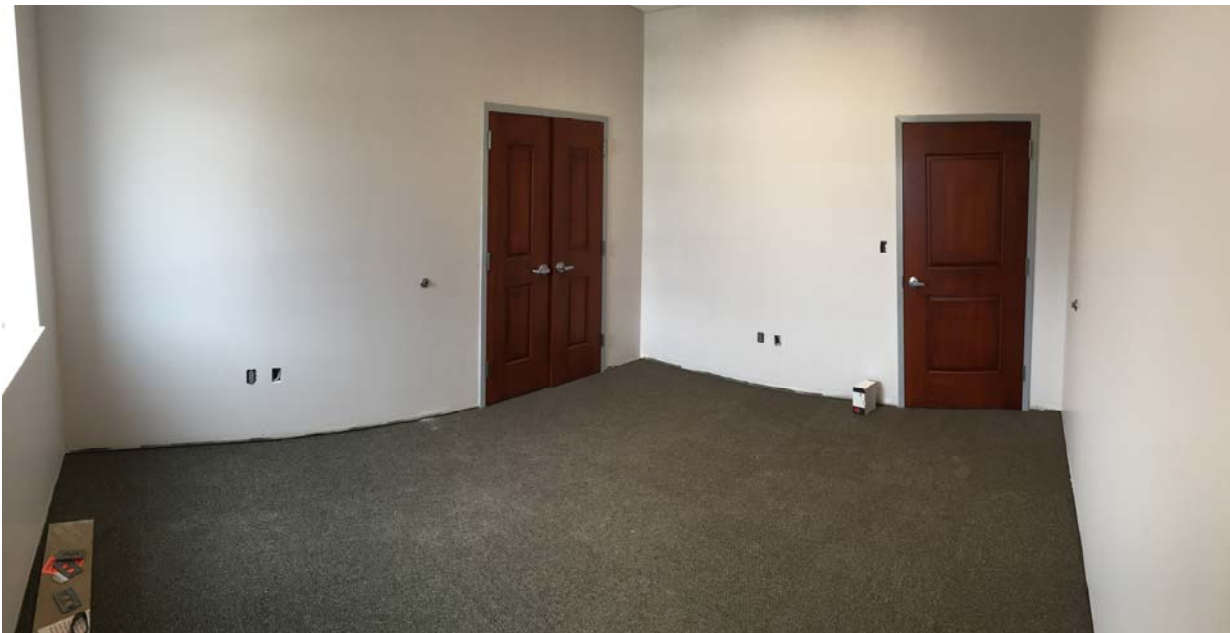
Office doors have been installed. Carpeting installed and walls painted. HM frames still needs to be painted.

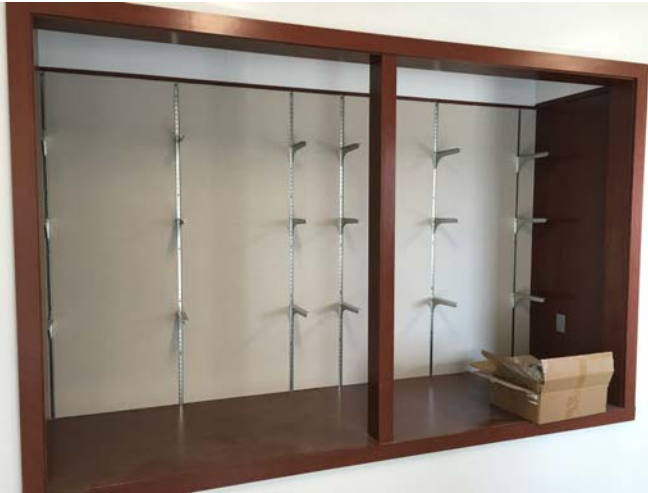
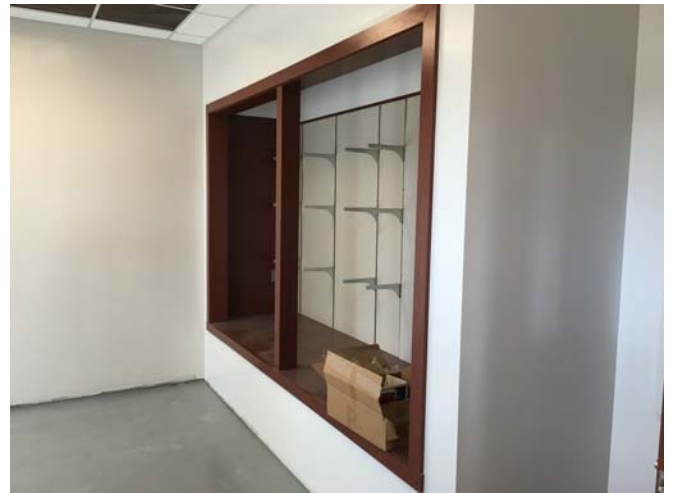
Views of completed display case installation completed

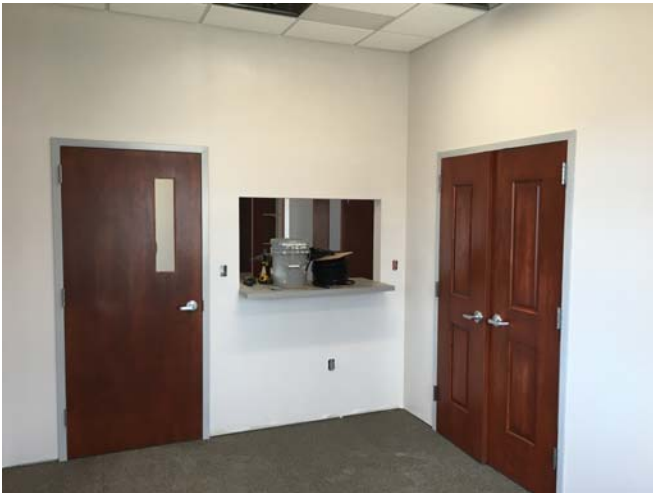
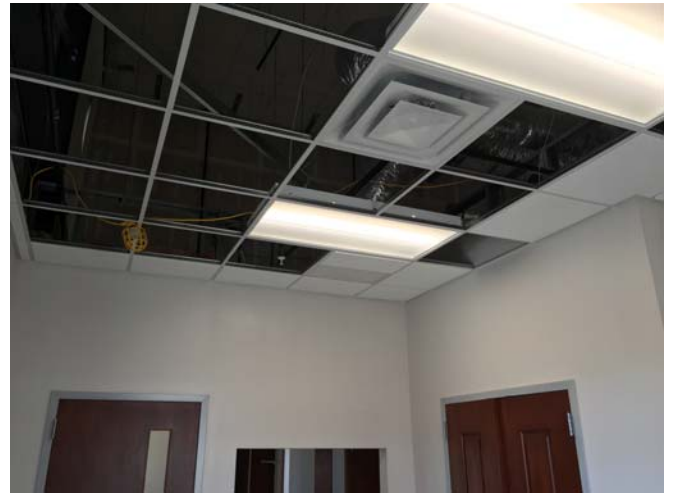
Views of dispatch office

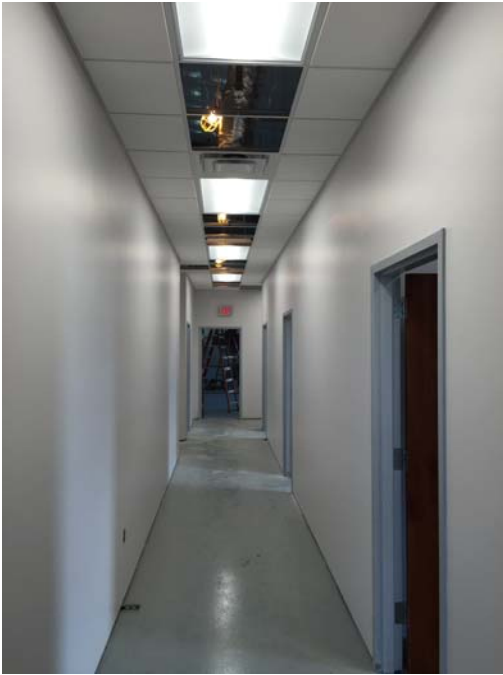
View down main corridor.

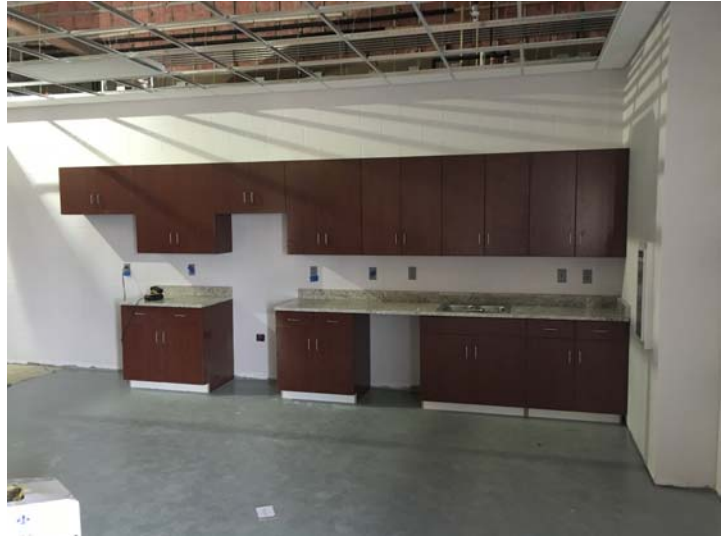
View of cabinetry in crew room

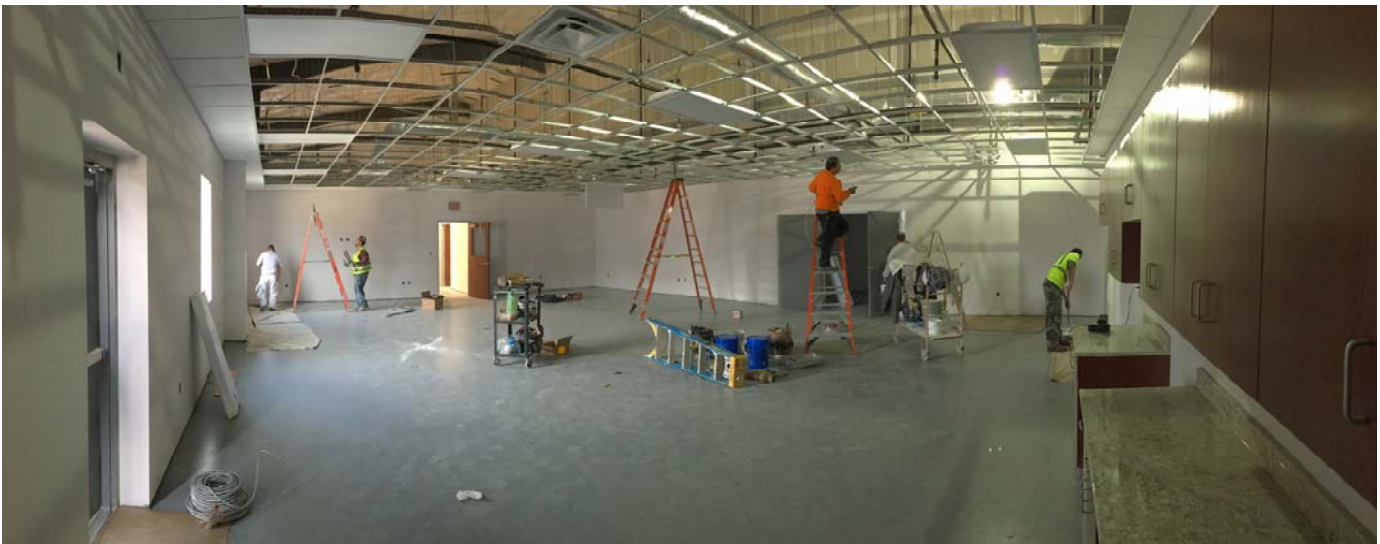
View of crew room. Ceiling grid have been installed. Interior painting ongoing. Epoxy flooring have been installed. Wiring for lighting is being installed.

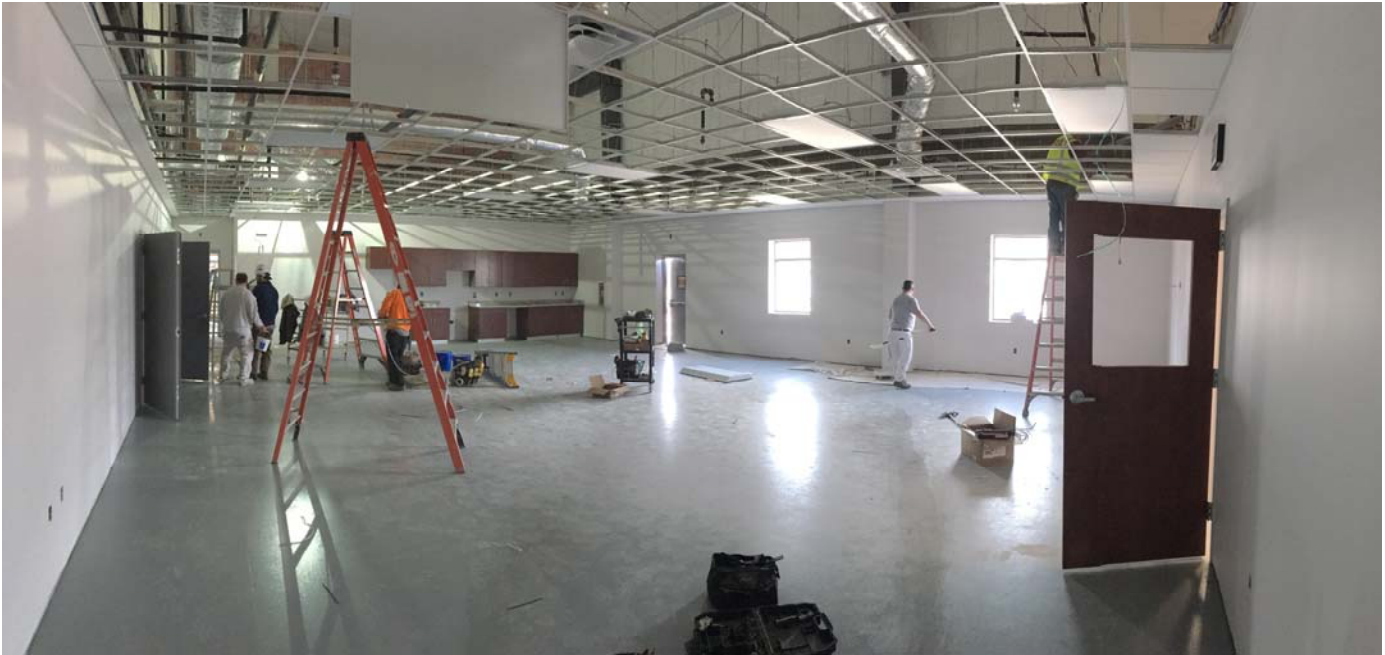
Another view of the crew room.

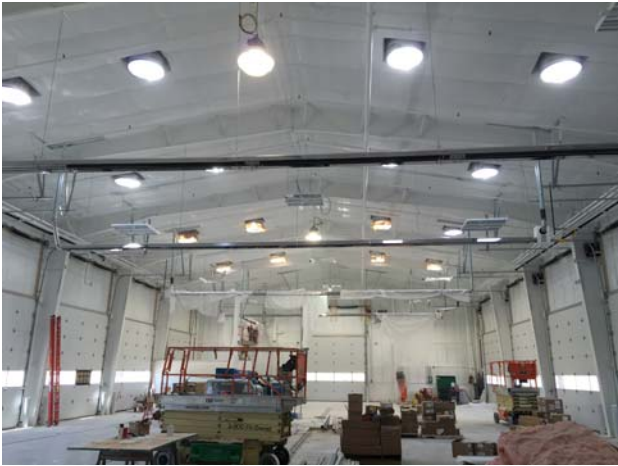
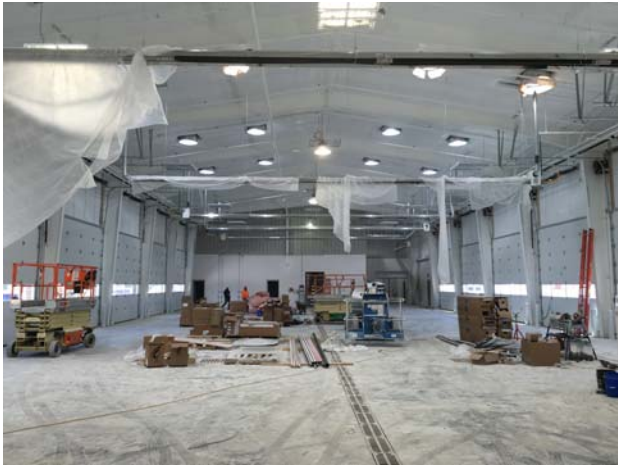
Views of the garage with the solartubes installed. Radiant heaters have been installed. Interior painting have been completed. All utility lines have been installed.

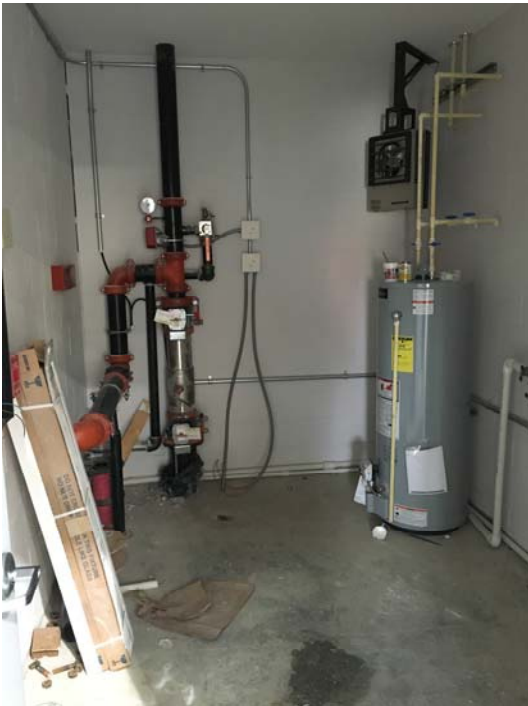
View of sprinkler riser room.

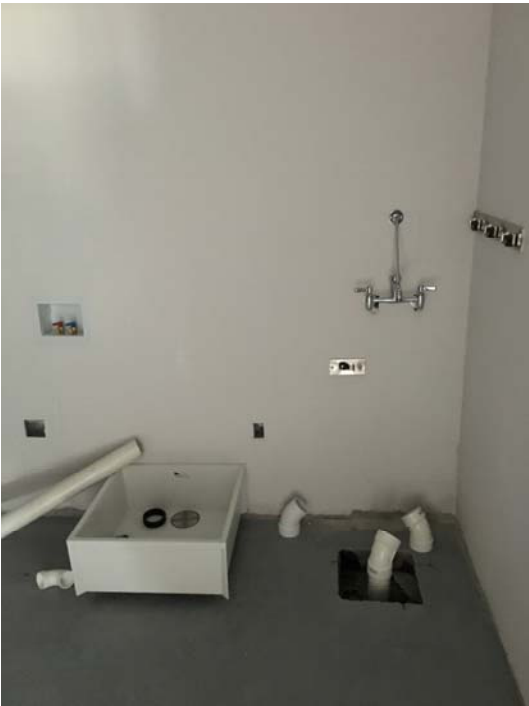
View of laundry room with mop sink roughed-in

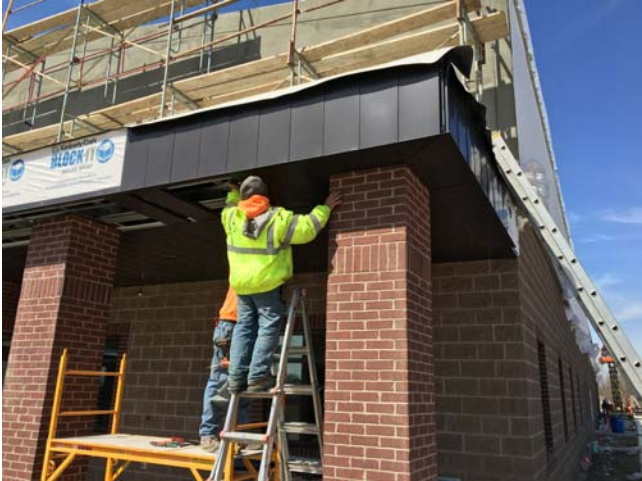
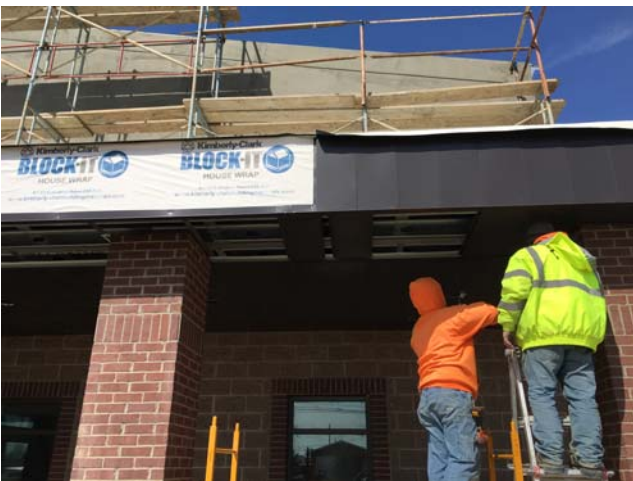
Views of canopy metal fascia and soffit panels.

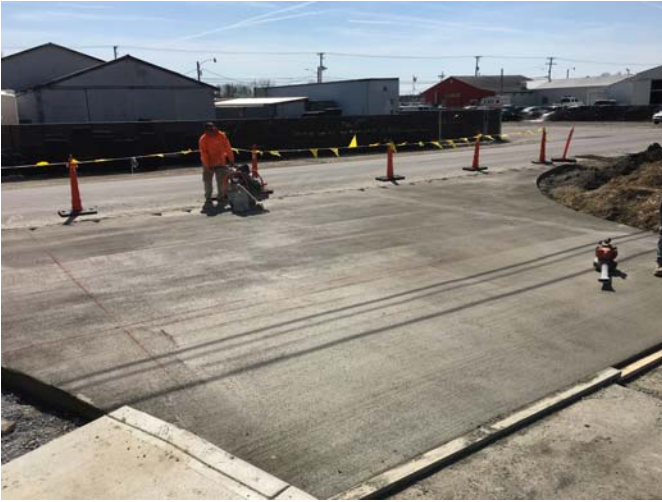
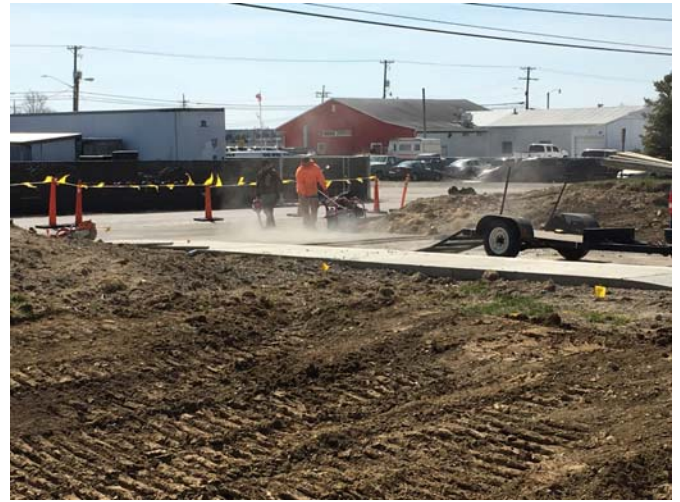
Views of driveway installation.

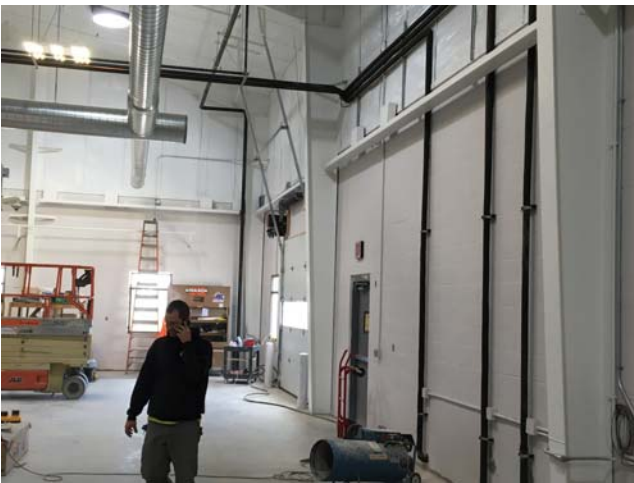
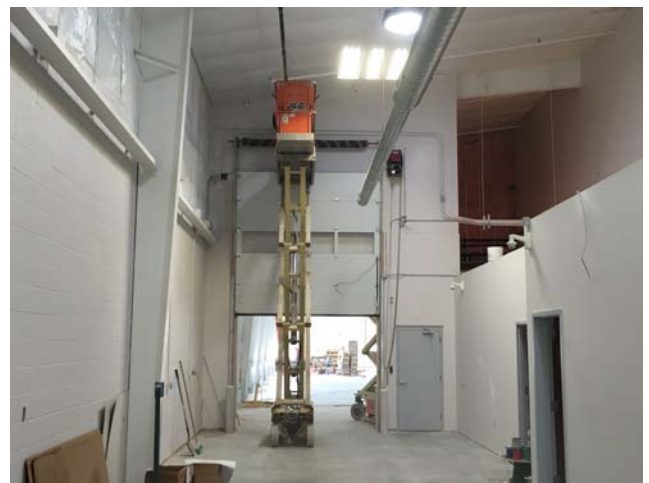
Views of meter department / storeroom. Interior painting completed. Gas and plumbing lines haven been installed.
